FOCUSED BIOLOGICAL ASSESSMENT  
LANDSLIDE REPAIR SITE AND STAGING AREA  
PALO CORONA REGIONAL PARK

Prepared by:  
Nicole Nedeff, Consulting Ecologist  
11630 McCarthy Road  
Carmel Valley, CA 93924  
[nikki@ventanaview.net](mailto:nikki@ventanaview.net) – 831.320.9463

June 4, 2018

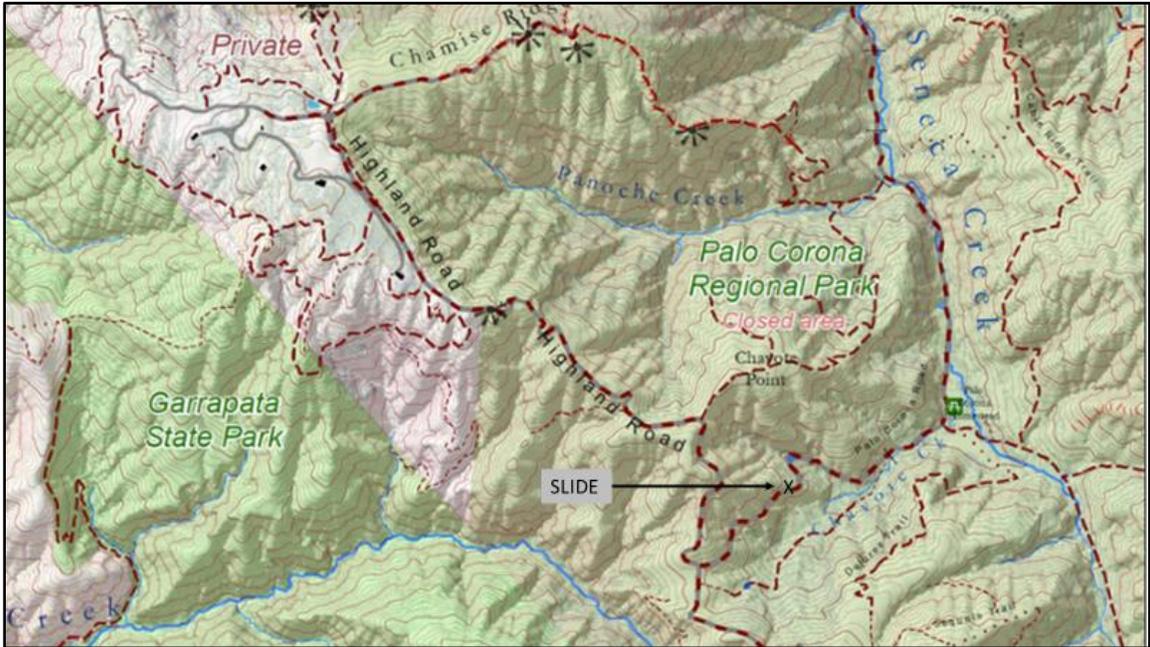
Figure 5 points out the landslide site. Basemap by Fred Watson (draft, in press).

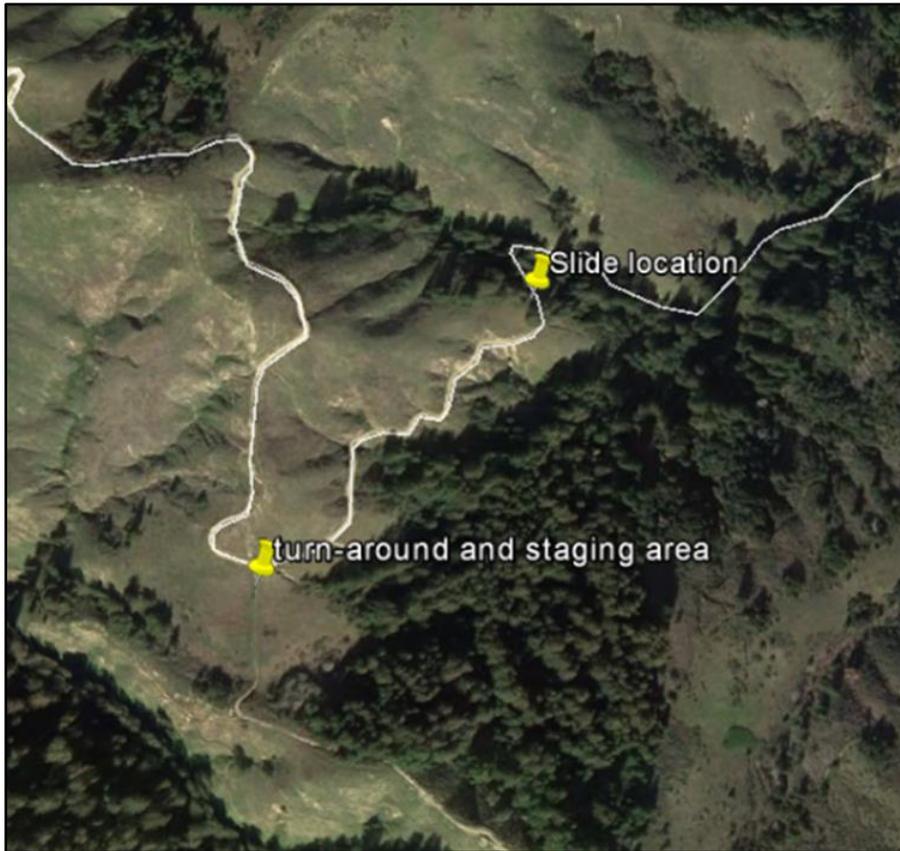
Figure 6 is a Google Earth image with work and staging sites noted by Nathaniel Milam, Whitson Engineers.

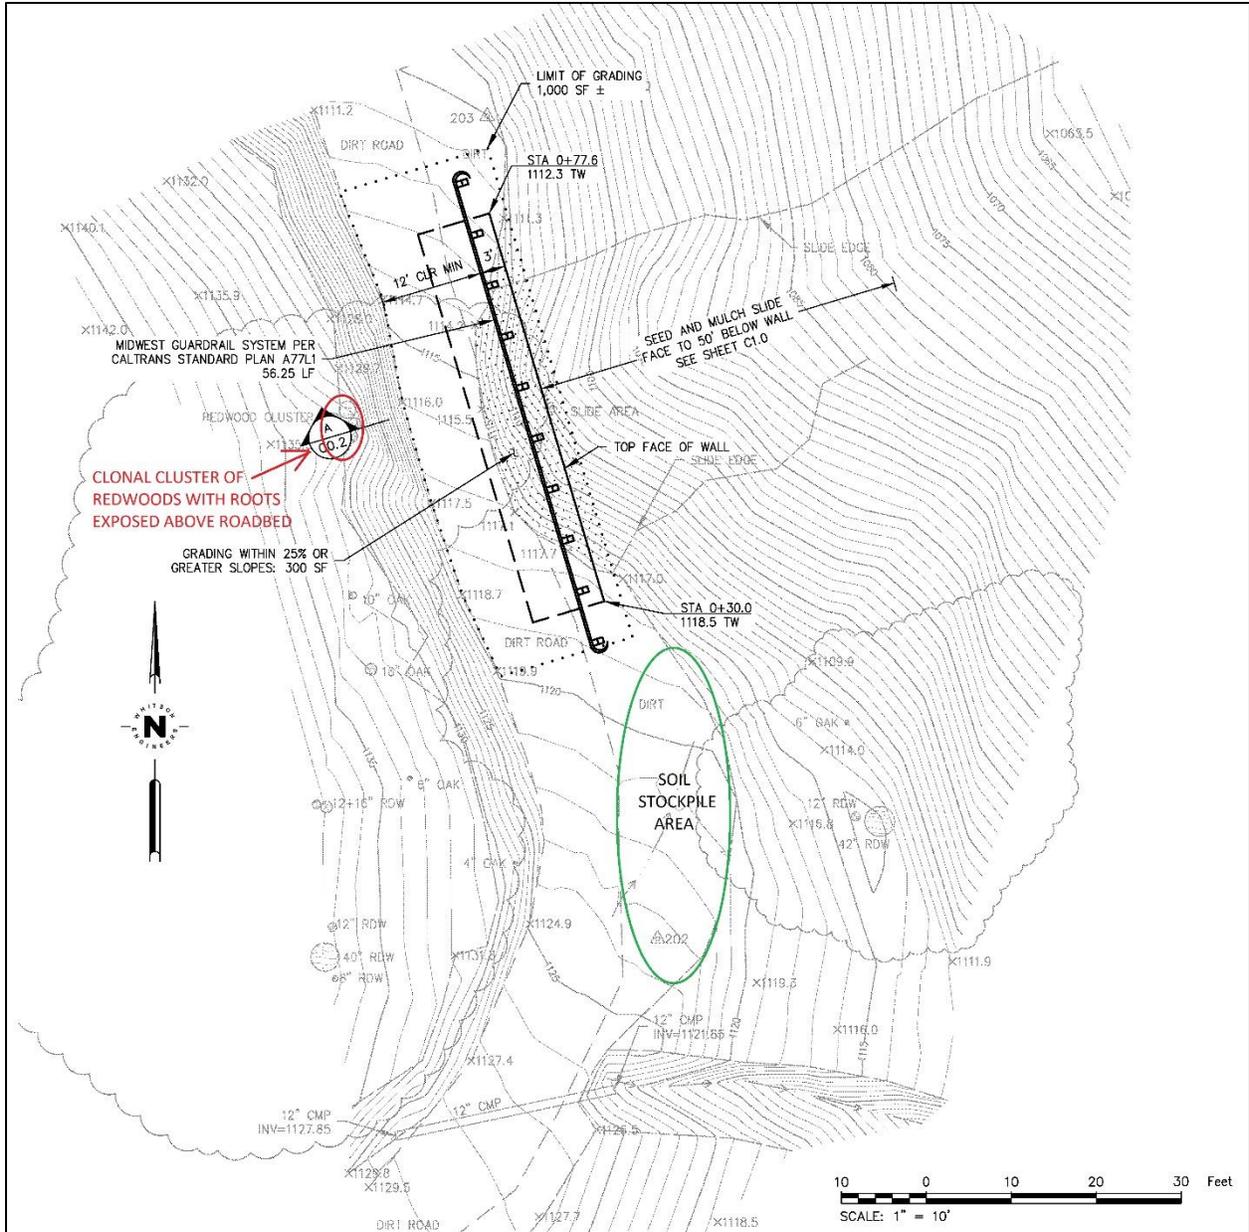
Figure 7 (next page) is a plan view from the engineering drawings prepared by Whitson Engineers. It displays the cluster of clonal redwoods above the landslide and the shoulder area to be used a stockpile location for excavated soil.

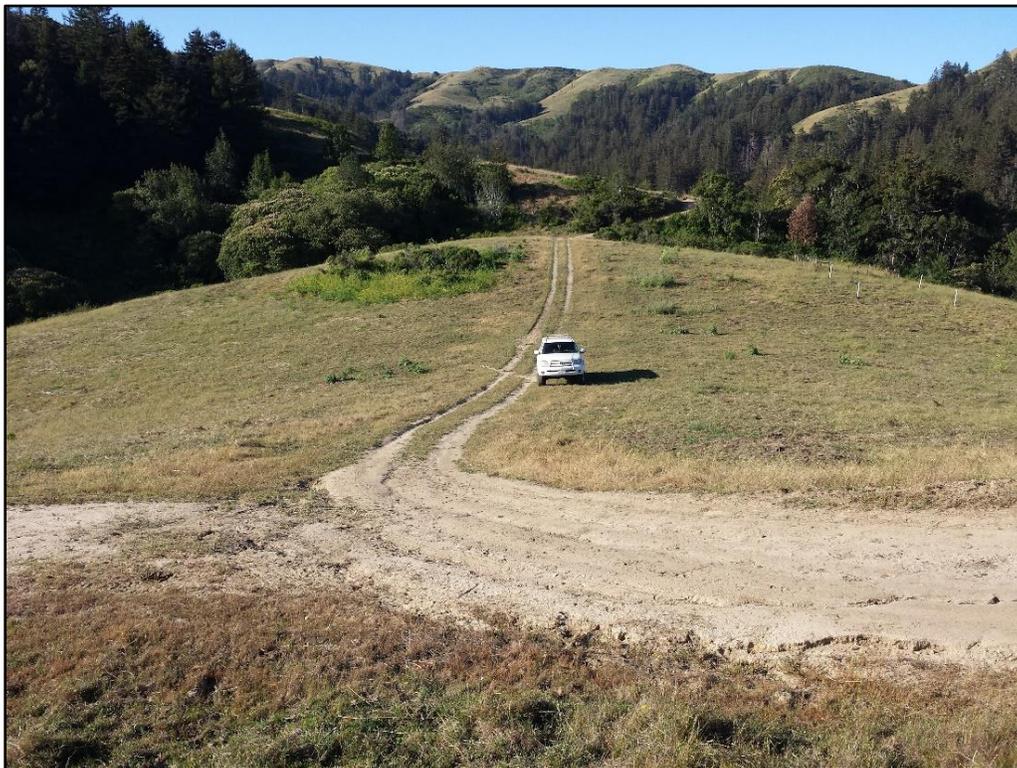
A. Staging and vehicle turn-around: Coastal Grassland habitat occurs in the area to be used for construction staging, vehicle turn-around and stockpiling of soil and crushed drain rock that will be used in in the hilfiker wall. The staging area is at the junction of two internal ranch roads. The area is relatively flat and occurs at the watershed divide between Chavote Creek to the east and Malpas Creek to the west. Small patches of invasive Italian and milk thistles, along with poison hemlock occur in the mix of native and non-native grasses at this site. Approximately 300 yards to the southeast of the staging area is the historic Chavote homestead, which is marked by horticultural rose bushes, red-hot poker aloe and a stalwart pear tree. No sensitive, or special status species will be impacted in the staging area if suggestions outlined in the Recommendations section of this report are implemented.

Figure 8 displays the construction staging area and vehicle turn-around site.

A. Staging and vehicle turn-around: The goal is to minimize compaction and damage to the Coastal Grassland area in the staging and turn-around site with the following suggestions:

1. Locate the imported rock stock-pile and any surplus excavated soil in the flat area on the west side of the ranch road.
2. Encircle surplus soil and imported rock with securely fastened fiber wattle. Remove wattle after project completion and dispose of in an appropriate waste facility.

3. Minimize the turn-around area used by construction vehicles and clearly designate areas of no-access with appropriate signage, particularly on the east side of the roadway above the historic Chavote homestead site.

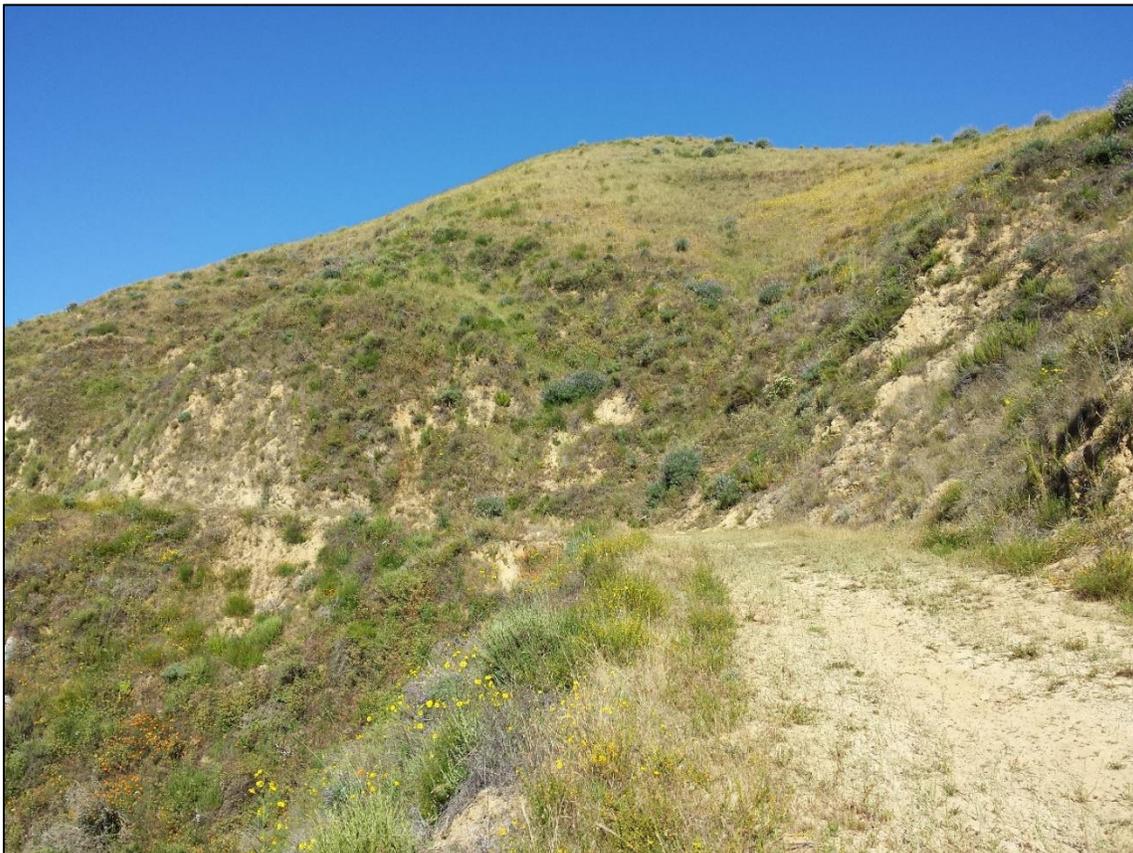
Figure 9 is a view looking uphill and “up-road” from the near the landslide repair site. Roadsides are vegetated with a diverse mix of Coastal Scrub species, including seacliff buckwheat.

1. To protect seacliff buckwheat plants growing along the road shoulder, all buckwheat plants on the road shoulder and within 2-feet of the both uphill and down-slope edges of the roadbed should be flagged for protection by the Project Biologist. This includes all plants above the toe of the roadcut, as well as below the roadbed.

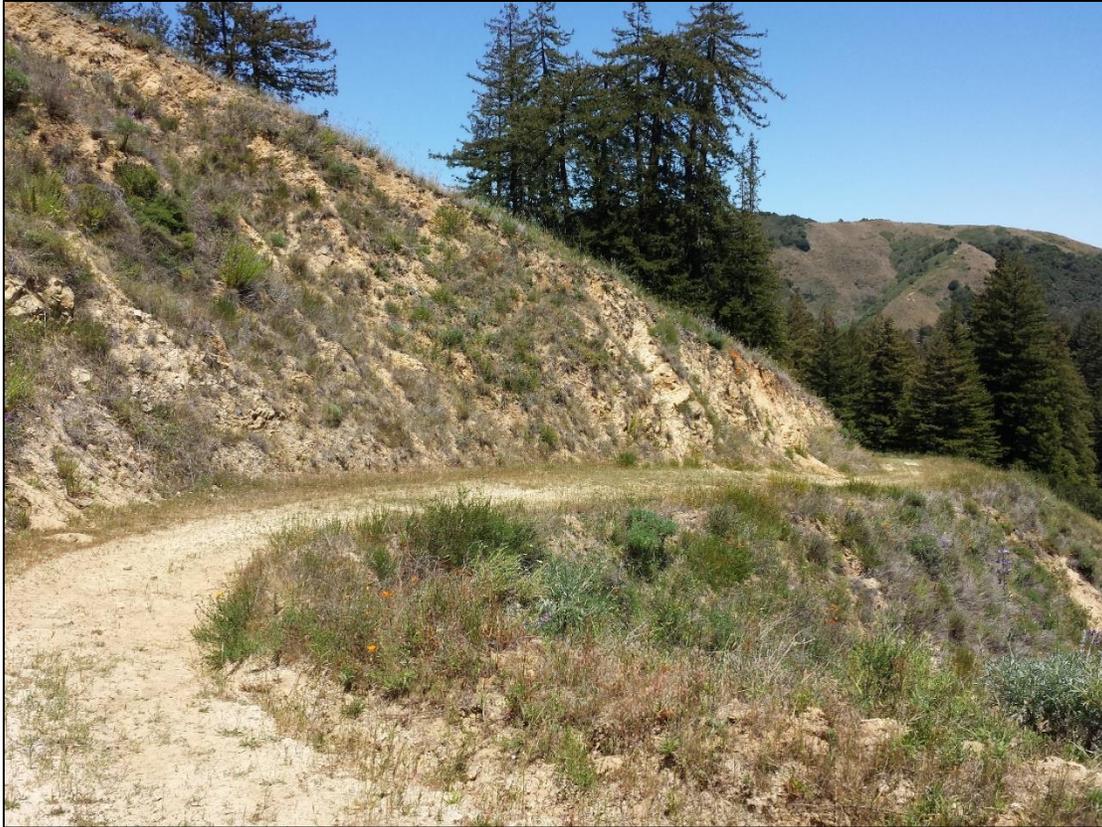
Figure 10 is looking down-hill towards the landslide repair site, which is around the corner just out of view. The roadcut above the ranch road, as well as the slope below the roadbed are vegetated with a mix of Coastal Scrub species, including seacliff buckwheat.

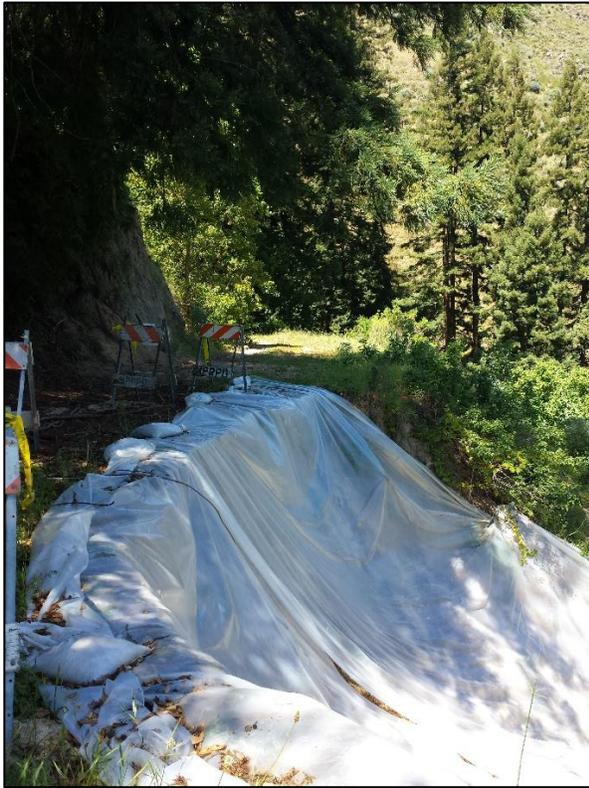
C. Landslide site: The site where the landslide is located occurs along a very steep slope near the transition between Redwood Forest and more open Scrub/Grassland habitats. The arc of the slip-out is approximately 50-feet in length and measures about 12-feet from the apex of the headwall of the slope failure to the edge of where the outer road shoulder used to be. The actual free face and debris slope of the landslide is completely obscured by plastic sheeting to reduce further erosion, however it appears that the vegetation dislodged when the landslide occurred was composed of poison oak and a mixture of Coastal Scrub and Redwood Forest understory plants.

Figure 11 - Landslide site.

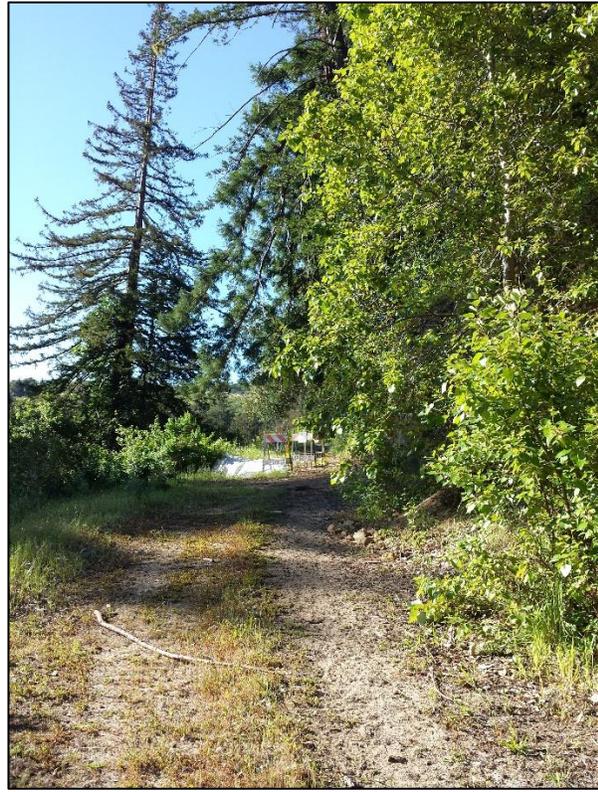
A small stand of black cottonwood occurs from 40-feet to 70-feet “down-road” of the apex of the slide headwall. The cottonwoods occur on the inside of the roadway and indicate that this area has a high degree of soil moisture, since black cottonwood readily sprouts and produces clonal tree stems from rhizomatous roots when abundant moisture persists in the root zone. The black cottonwood stand will not be impacted by landslide repair.

Figure 12 - Looking uphill to the landslide (photo center). The stand of cottonwoods is on the right.

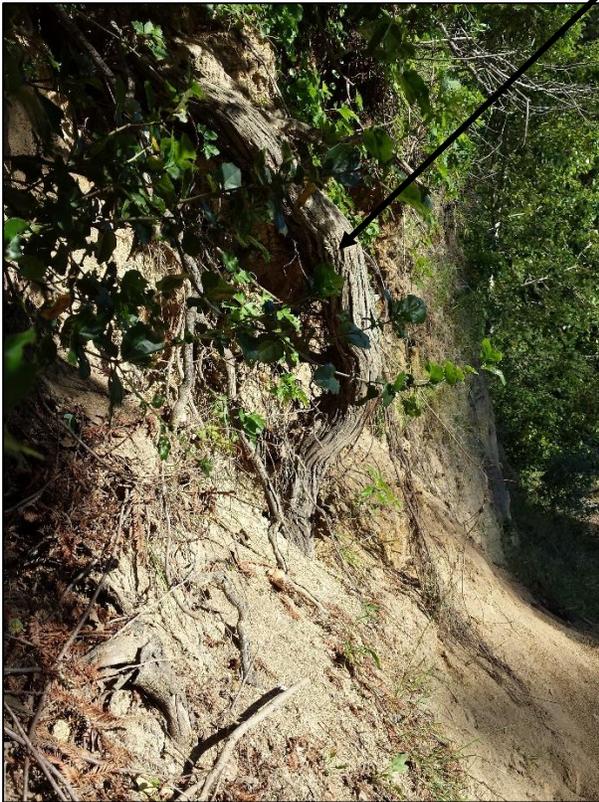
Several coast live oak saplings with DBH (Diameter at Breast Height) less than 2-inches have recruited in soil exposed on the roadcut above the landslide. Immediately above the roadcut where the landslide occurred is a mature cluster of clonal redwood trees that appears to have sprouted from a common stump. A few of the major stump roots are exposed – it appears that the roots were likely damaged when the original Palo Corona ranch road was cut into the steep slope immediately below the trees. Over time, several of the primary roots have become increasingly exposed as the headwall of the roadcut eroded and sloughed away. Colluvium at the toe of the roadcut supports this observation.

The 14-foot deep excavation required to construct the hilfiker wall may further damage the root structure of this cluster of clonal redwood trees. Redwood roots are generally shallow and spread in a wide, lateral net around parent trees and it is possible that roots of the redwood cluster above the slide have penetrated below the roadbed that will be excavated to construct the hilfiker wall. However, it is not possible at this time to know definitively whether any redwood roots occur under the roadbed below the clonal cluster of redwoods. No roots were visible through the plastic sheeting covering the debris slope of the slide, so it could not be determined whether any redwood roots are growing under and through the roadway. If recommendations presented in the following section of the report are adopted, no significant, or lasting impacts will occur to the

Exposed redwood roots from base of stump above the roadcut.

Figure 13 – Exposed redwood roots in the old Roadcut above the apex of the landslide.

7. If possible, during excavation for the hilfiker wall, avoid severing redwood roots that may be growing below the roadway.
8. Avoid damaging or further exposing redwood tree roots that are currently visible above the roadbed.

10. If tree roots are damaged during excavation, consult with of a Registered Professional Forester, or a Certified Arborist and develop a strategy to stabilize the trees, if necessary.

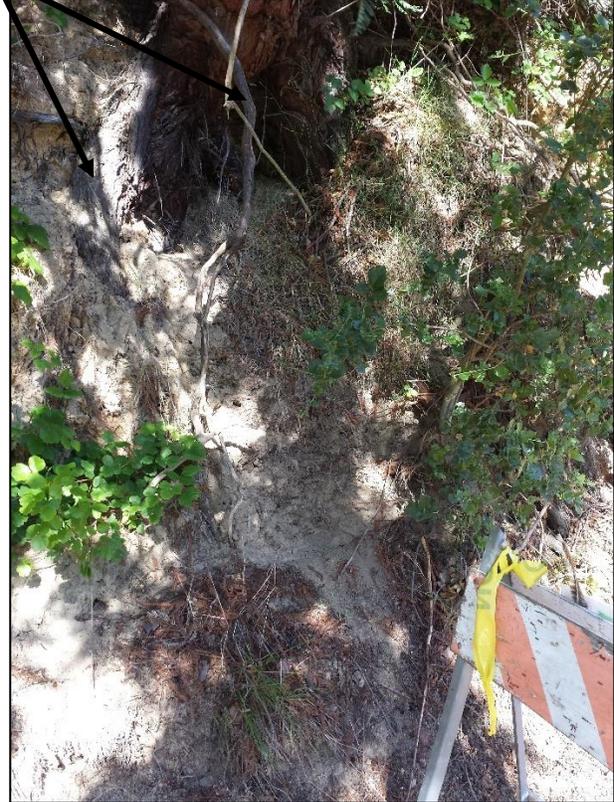
Figure 14 – Exposed redwood roots.
